CITY OF FLORENCE
SITE INVESTIGATION REPORT PHASE 2

Build SFD on lot 37 skeltrcur
Proposal

56 Shoreline dr Florence
Street Address

**RE: EROSION/RECESSION SITE ASSESSMENT
LOT 37 SHELTER COVE
FLORENCE, OREGON
BRANCH ENGINEERING INC. PROJECT NO. 21-335**

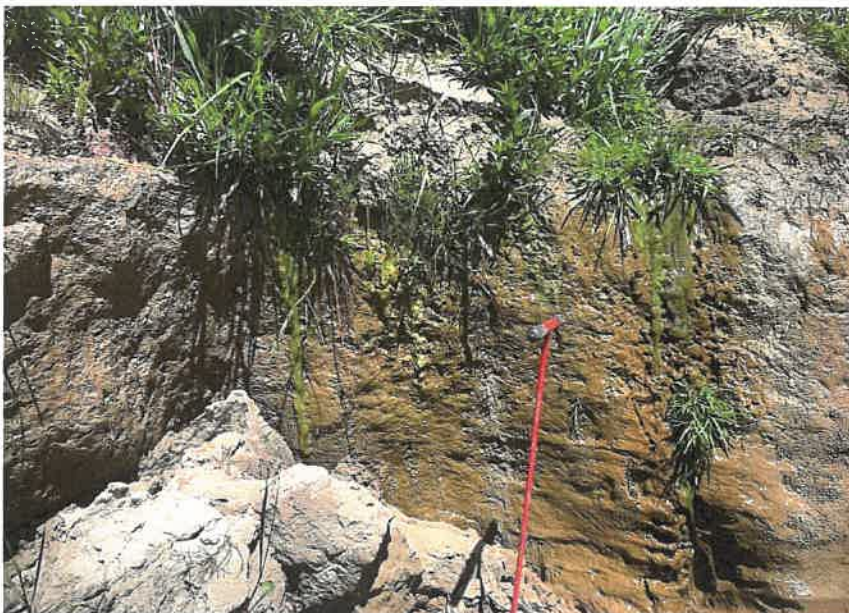
To assess the soil type and groundwater during the May 31, 2022 site investigation BEI staff accessed the bay frontage of the property. The MTD deposits along the adjacent lot to the north were exposed and consisted of dense partially cemented, poorly graded sand with silt and clay. The MTD deposits above the waterline stood vertical for approximately 3- to 7-feet in height, the MTD deposits extended below the waterline to an unknown depth. An area of deposition along the piers near Cannery Point was noted from drone photos. In this area it appears the MTD deposits extend further out into the bay. Hand probing areas close to shore had 1- to 2-feet of loose sand overlying the MTD shelf that projected out into the bay. Groundwater was noted issuing from the boundary between the MTD deposits and the overlying sand. The rate varied, but was estimated to be at least a gallon per minute in areas where erosion had concentrated the flow. Piping of the overlying sand deposits was noted where the groundwater flow volume was highest. Deposits of the sand were also noted in the water below these areas.

Photo 1: MTD deposits and groundwater issuing from the boundary with overlying sand.

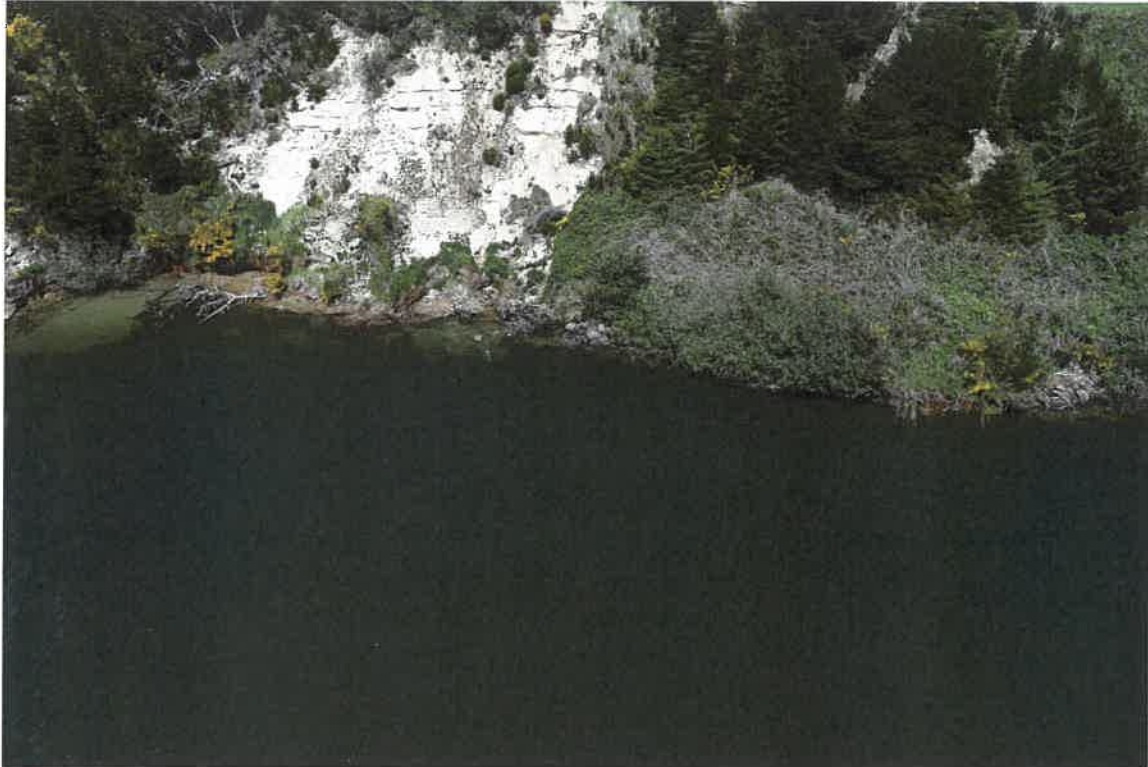
Based on historical imagery obtained from EDR Lightbox (attached) for the following years 1954, 1976, 1982, 1988, 1994, 2000, 2005, 2009, 2012, 2016, and Google Earth Imagery for the years 2005, 2012, 2016, and 2019, the site has experienced periods of bay shore erosion; however, the most significant alternation to the site is associated with mass grading of the area during the development of the Shelter Cove subdivision. The resolution of the aerial images also makes determining a rate of erosion for the site difficult as the precision of any measurements would be on the order of tens of feet. The 1954 aerial photo shows the site vicinity as partially vegetated dunes descending as sand clear of vegetation to the river bank. By 1976 a series of four groins (constructed in 1974) on the south bank of Siuslaw Bay. One of the groins is directly across the bay from the site. Also visible in the 1976 aerial photo is an area of sand clear of vegetation in the site vicinity. This area was vegetated in the 1954 aerial photo. The site vicinity remains relatively unchanged until the 1994 aerial image that shows construction of the Shelter Cove subdivision altering the site and vicinity by removing vegetation and performing mass grading operations. Mass grading of the site appears to consist of a flattening of the dune for a building pad and clearing of the slope to the bay. In the 1994 aerial photo the slopes descending to Siuslaw Bay are mostly clear of vegetation and remain relatively clear until the 2009 to 2012 aerial photos that show sparse vegetation in 2009, and relatively dense vegetation in 2012. Sometime between 2012 and the next available aerial image in 2016, a shallow landslide begins to develop on the adjacent lot’s bayside slopes to the north. At the time of BEI site visits in 2021 and 2022 the landslide appeared to be entirely within the adjacent lot to the north; however, we were not able to locate property corners so this could not be confirmed. The exact cause of the landslide is unknown, but based on the lack of rip-rap armoring, we suspect that a combination of piping of the sand overlying the MTD deposits, and erosion of the MTD deposits lead to recession at the toe of the slope to the point where the overlying sand experienced a loss of lateral support and translational landslide resulted. Because of the dense vegetation along the slope and bay frontage of Lot 37, the site investigation was limited to the periphery and aerial reconnaissance using a drone. The bay frontage of the site appears to be composed of rip-rap that extends up into the vegetation a distance of 3- to 4-feet where it was visible. Below the vegetation line, which roughly corresponds to the high-water line, the rip-rap extends for a short distance before the shore drops off near vertical, to vertical with depths greater than 6-feet (estimated with a stick at the northwest corner). Drone photographs show the conditions observed in the northwest corner to be consistent along the length of the property. Shadows along the submerged bank indicate possible areas of concavity that may be undercut submerged banks in the MTD deposits.

Photo 2: Lot 36 (presumed left of vegetation line) and part of Lot 37 are visible in this photo. Note the exposed sand from the landslide on Lot 36, loose sand deposited below the waterline on left half of photo, and the dense vegetation and deeply incised banks below the waterline on Lot 37.

At the time of our site observations site slopes and the shoreline appear to be stable; however, if left unchecked the erosion of submerged bank material is expected to continue. To determine a site-specific rate of erosion and possible mitigation methods, the shoreline of the site would need to be accurately surveyed. If possible, an investigation utilizing either sonar, or if conditions permit, a water-based reconnaissance of the conditions below the waterline would need to be conducted. A survey of the site would also determine if the landslide on the adjacent lot was contained within that lot.

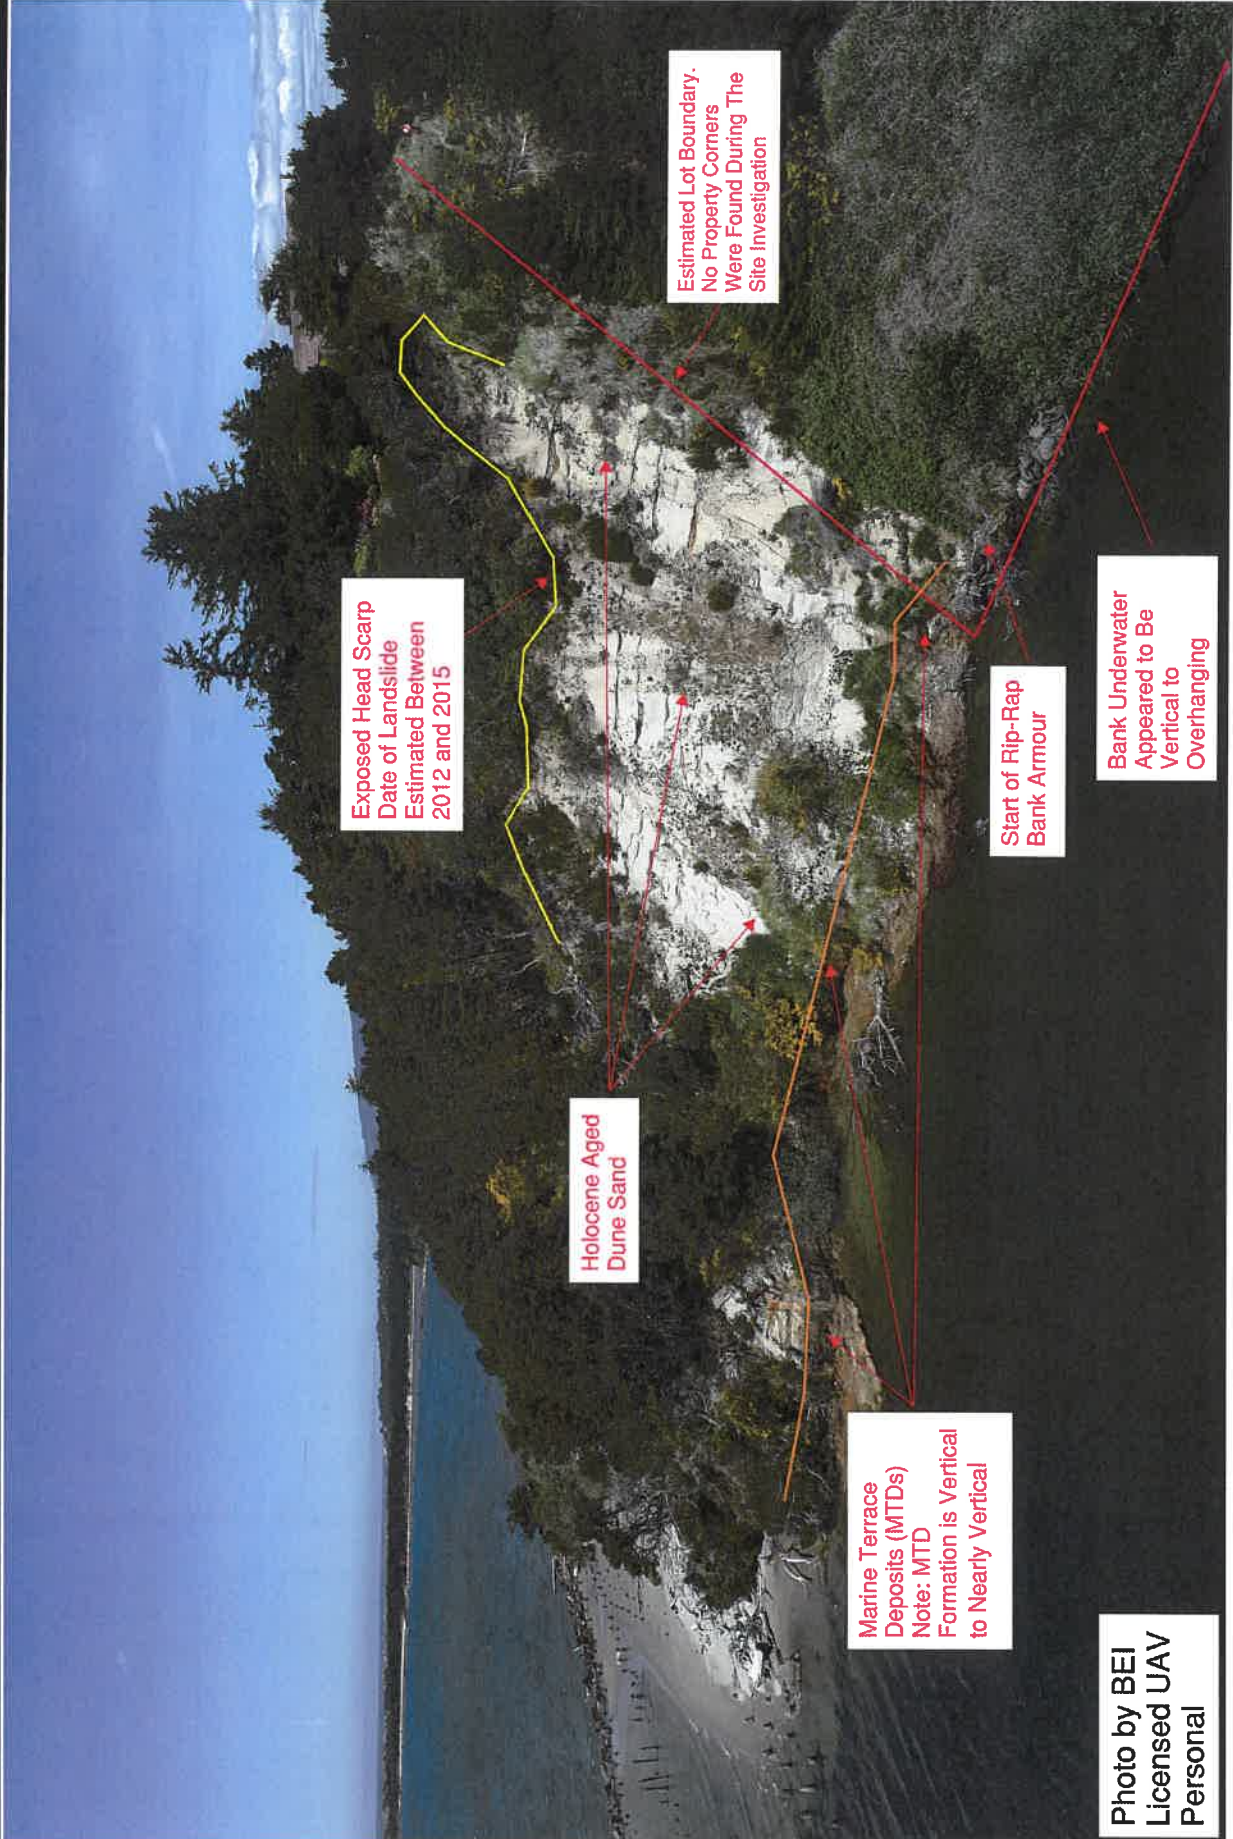
FIGURE-4
6-20-2022

Exposed Head Scarp
Date of Landslide
Estimated Between
2012 and 2015

Marine Terrace
Deposits (MTDs)
Note: MTD
Formation is Vertical
to Nearly Vertical

Start of Rip-Rap
Bank Armour

Bank Underwater
Appeared to Be
Vertical to
Overhanging
