Re: **Dune Stabilization  
Shelter Cover  
Florence, Oregon**

**Project 203.081**

## **Addendum #1 (Technical Memorandum)**

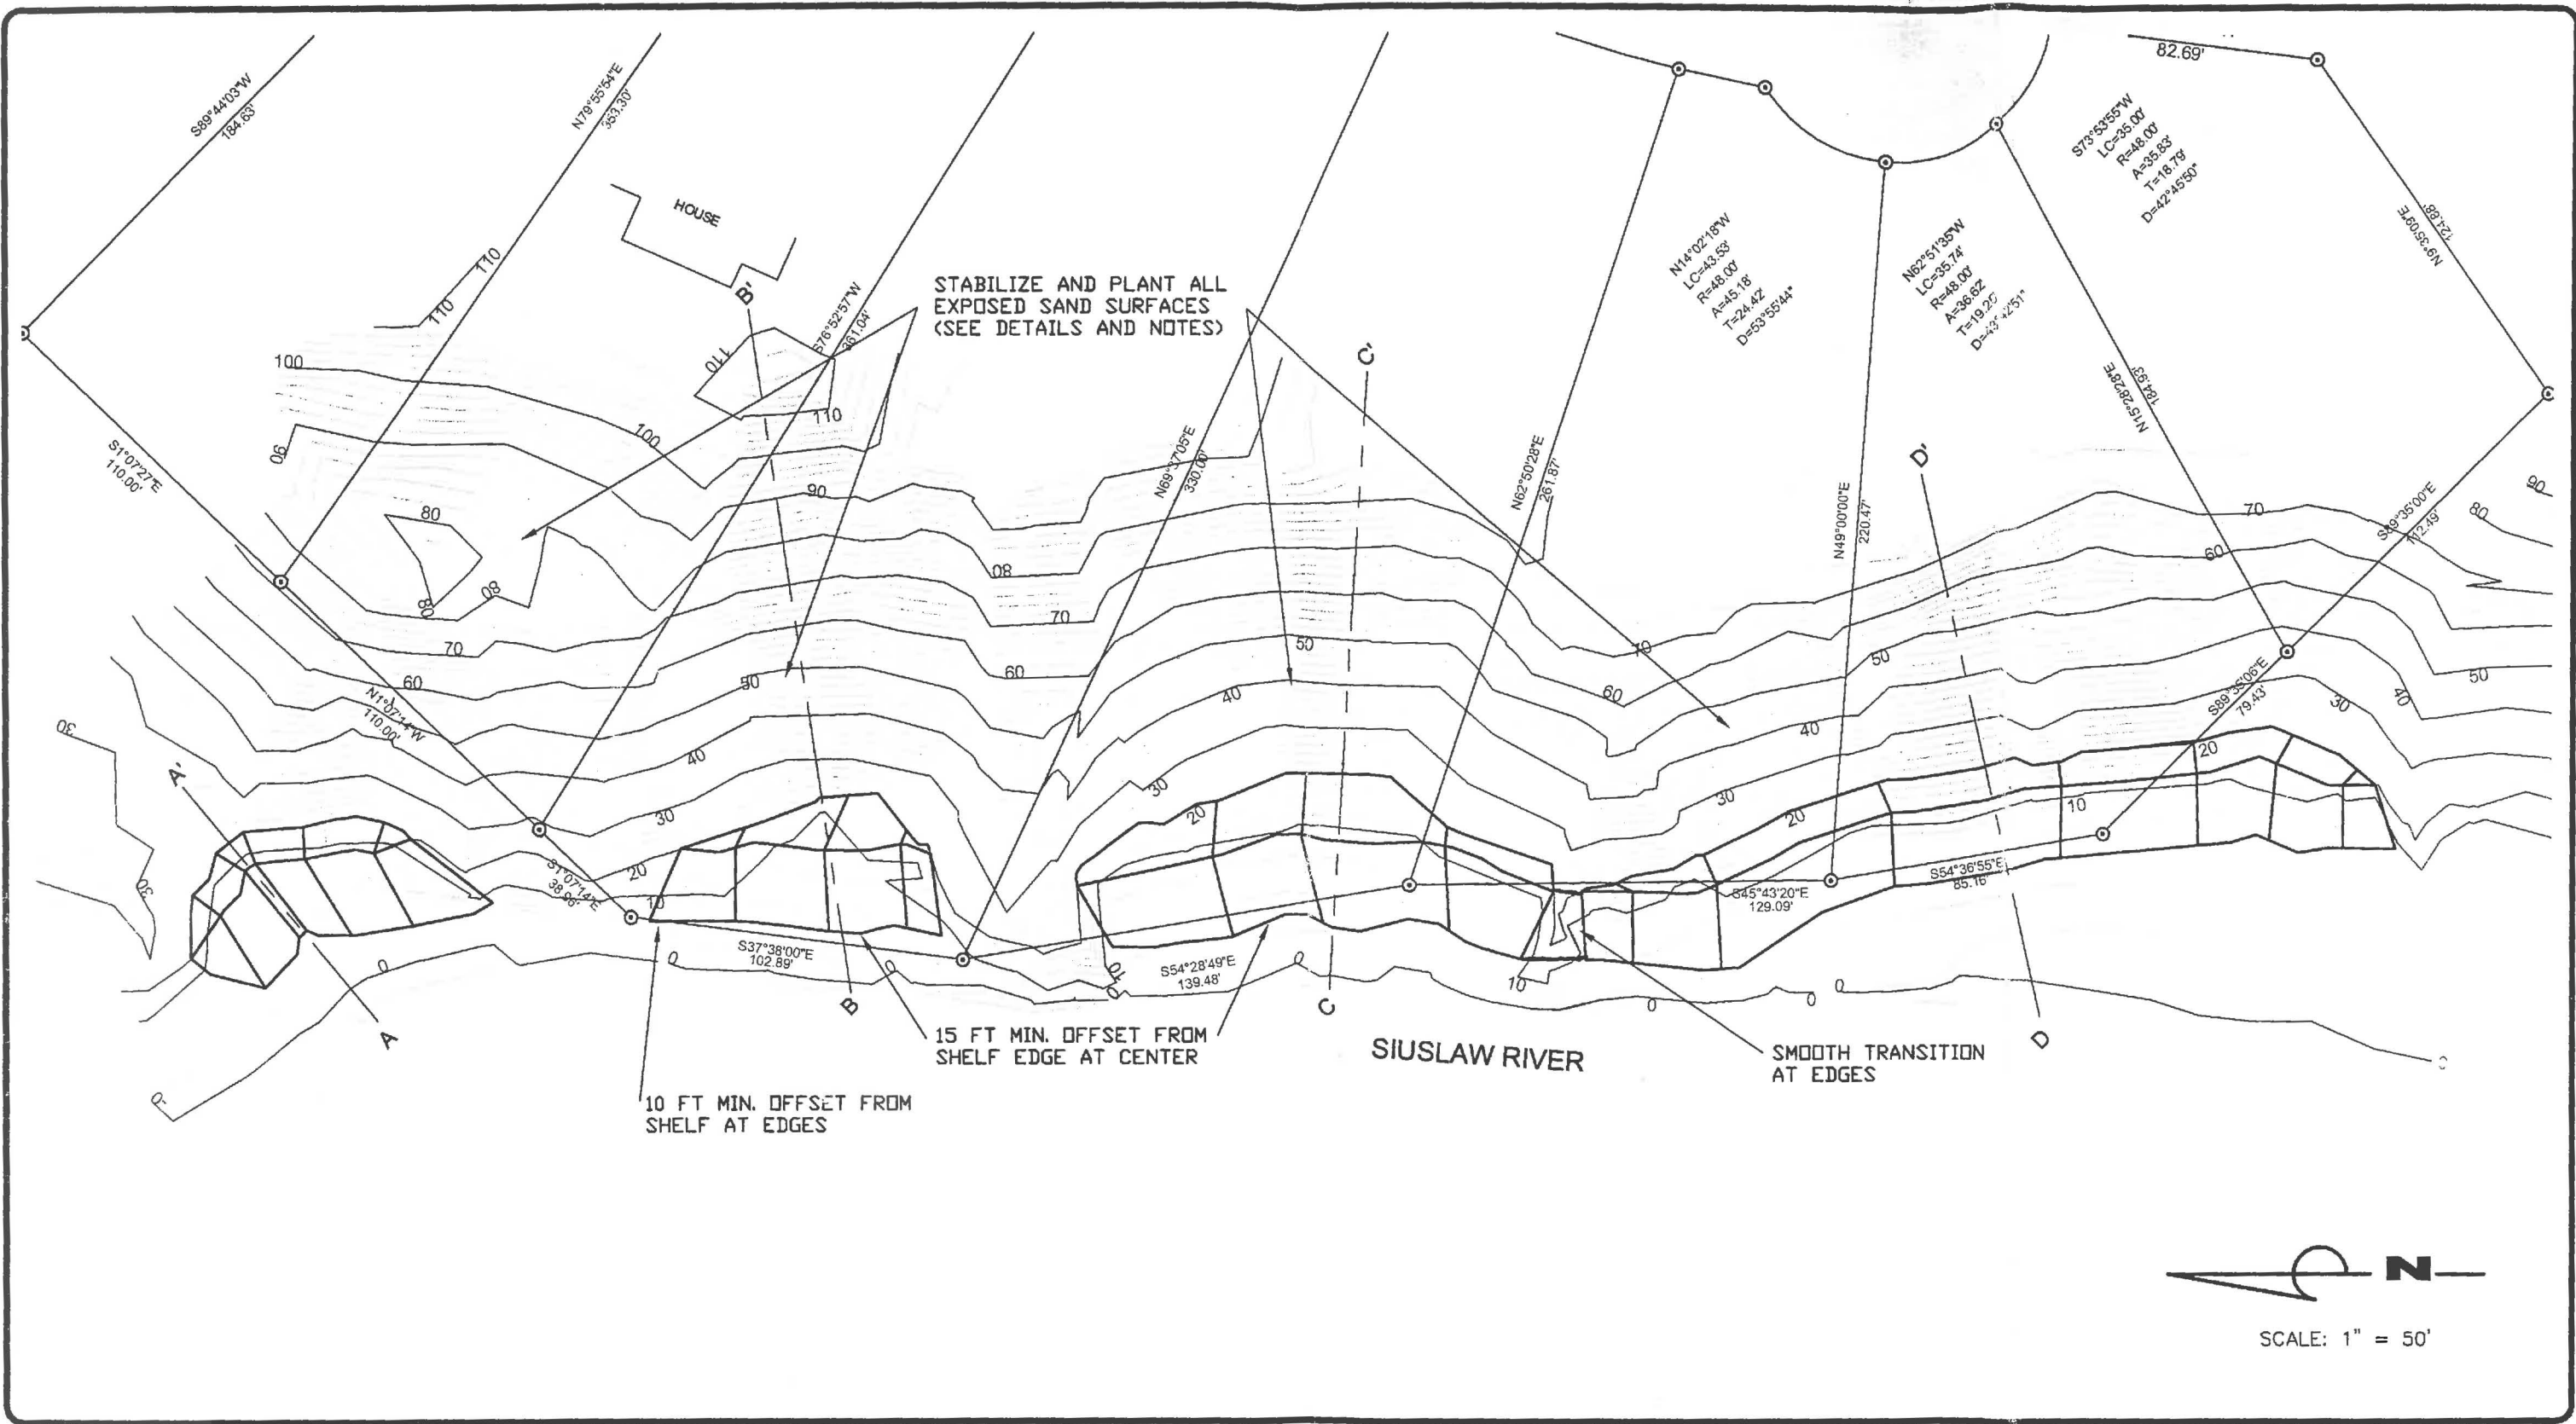
FIGURE NO.  
1

Using *Rip-Rap* and other graded aggregates, we designed a series of revetments as shown in Figure 1. The primary factors directing the design were the ledge of compressed silt at the base of the sand and the elevation of the water during high tide. Based on water elevations, scour, and wave action, we established 12 ft (about the mean high tide elevation) as a practical minimum height of the *Rip-Rap* revetment.

The final design is shown in the attached plan (Figure 1), corresponding slope sections (Figure 2 through 5) and a revetment detail (Figure 6). Note that two limiting constraints were created by the sand ridges and lack of available ledge space between each of the discrete areas. This created four discrete areas for *Rip-Rap* protections as denoted by cross-section A-A', B-B' C-C' and D-D'. The separating ridge areas would not be protected; however; these areas do not appear to have suffered greatly from erosion since the development was platted. It is possible future maintenance and/or slope protections may be needed in these intermediate areas, depending on the performance and secondary impacts of the shore protection.
