W A V E B E A C H G R A S S N U R S E R Y

July 10, 1992

Re: Shelter Cove Subdivision Phase II

RE: Shelter Cove Subdivision Phase II for Jim Hurst - Florence,
Lane County, Oregon.

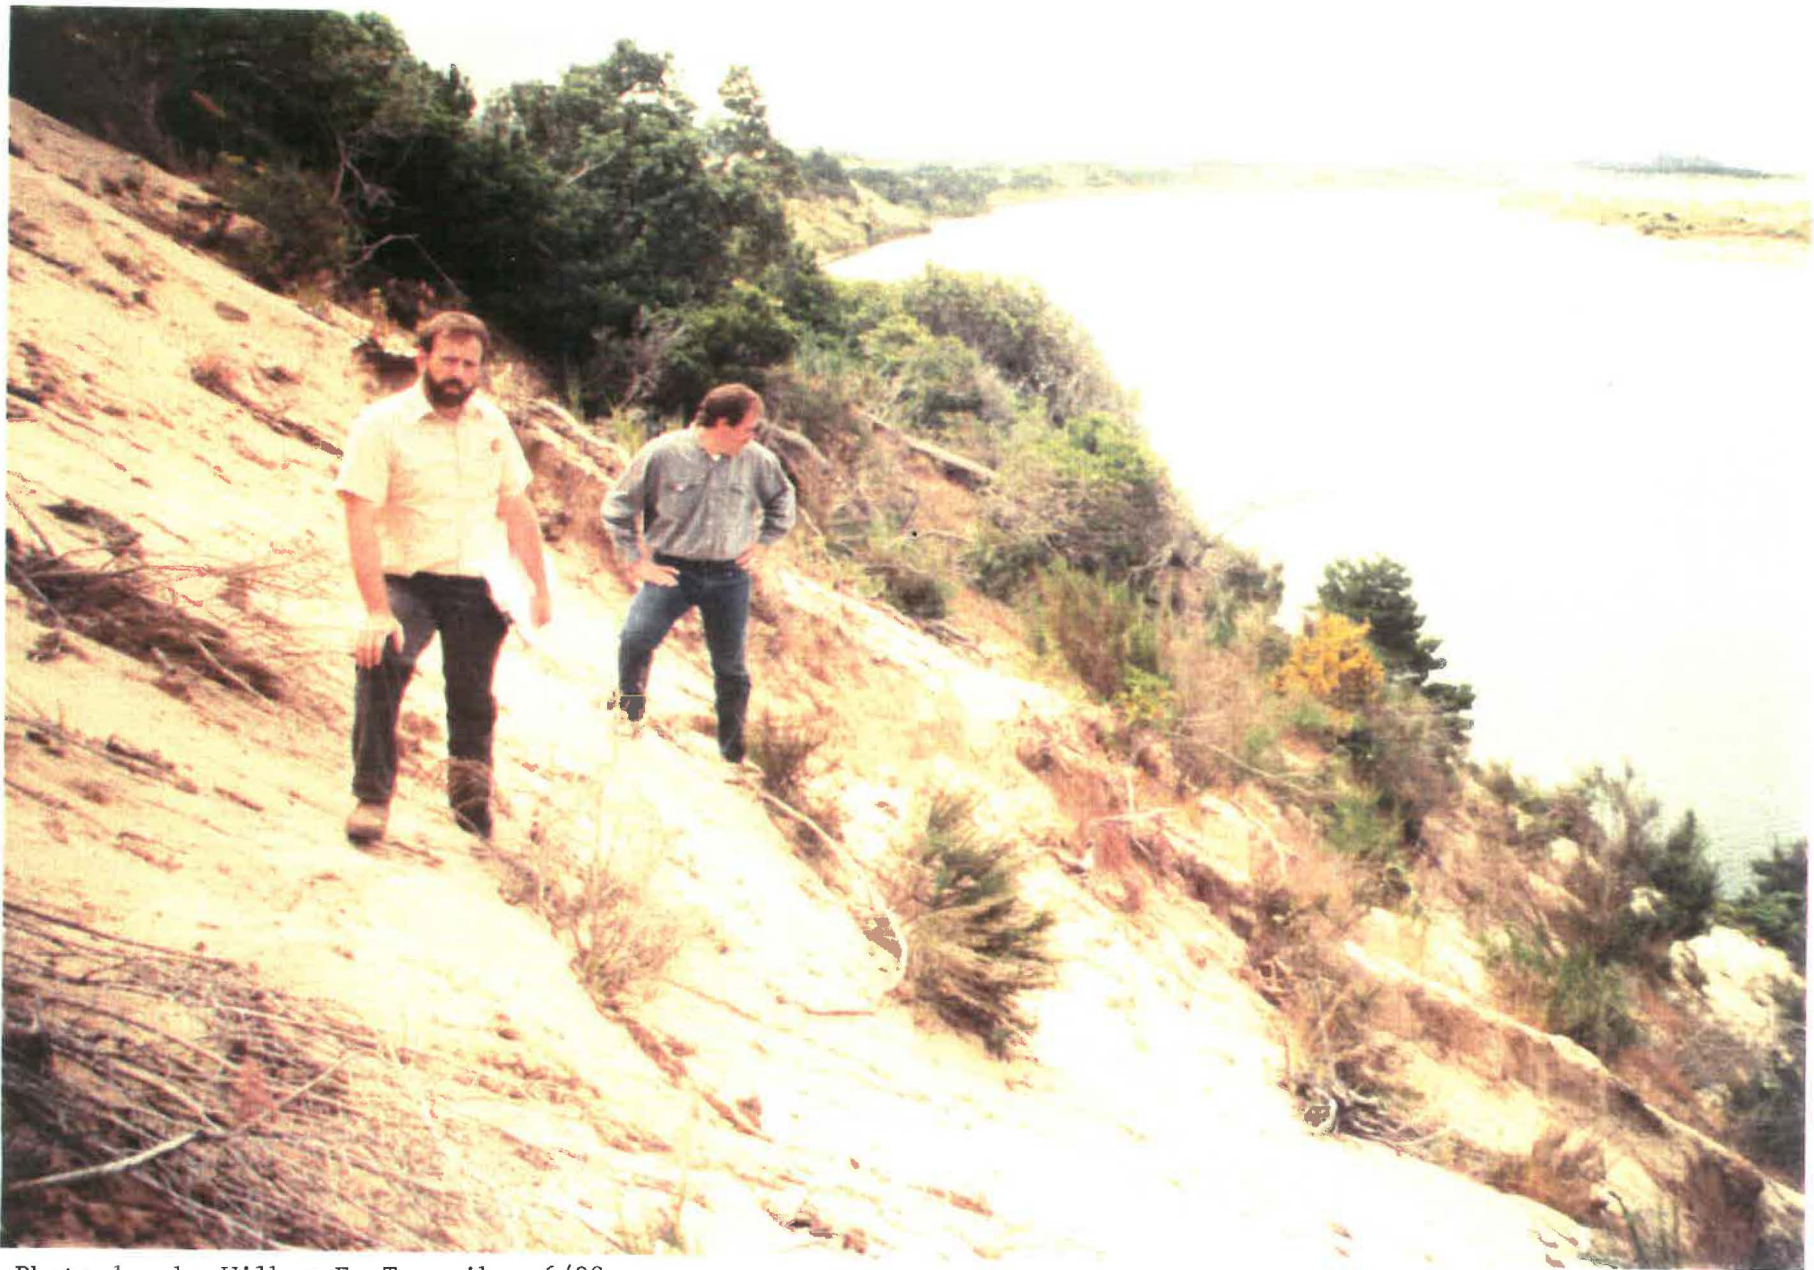
Photo 1 - by Wilbur E. Ternyik - 6/92

Recent events concerning site conditions related to river erosion and resulting in slope failure fronting the Siuslaw River prompted this letter. The necessary permits allowing us to rip rap the severe erosion areas have been turned down due to objections from LCDC. Since we are now well into the 92 construction season timing is critical if we are to move forward this year.

However, it also keeps the deep water channel against the Shelter Cove property. The rate of erosion at the toe of the slope in Area "B" is estimated at 2' per year. This results in the slope failure above. The rip rap permit insures that the erosion will continue unabated into the future.

Location - Jim Hurst's Shelter Cove Subdivision, Siuslaw River, Florence, Oregon.

Gene Wobbe and Don Hazen standing in middle of upper portion of slide area, on Lots 37 and 38.

Note - Progressive nature of slope failure and shrubs sliding down the slope, into the river.

Restoration of riparian vegetation is impossible until river toe of slope is stabilized.

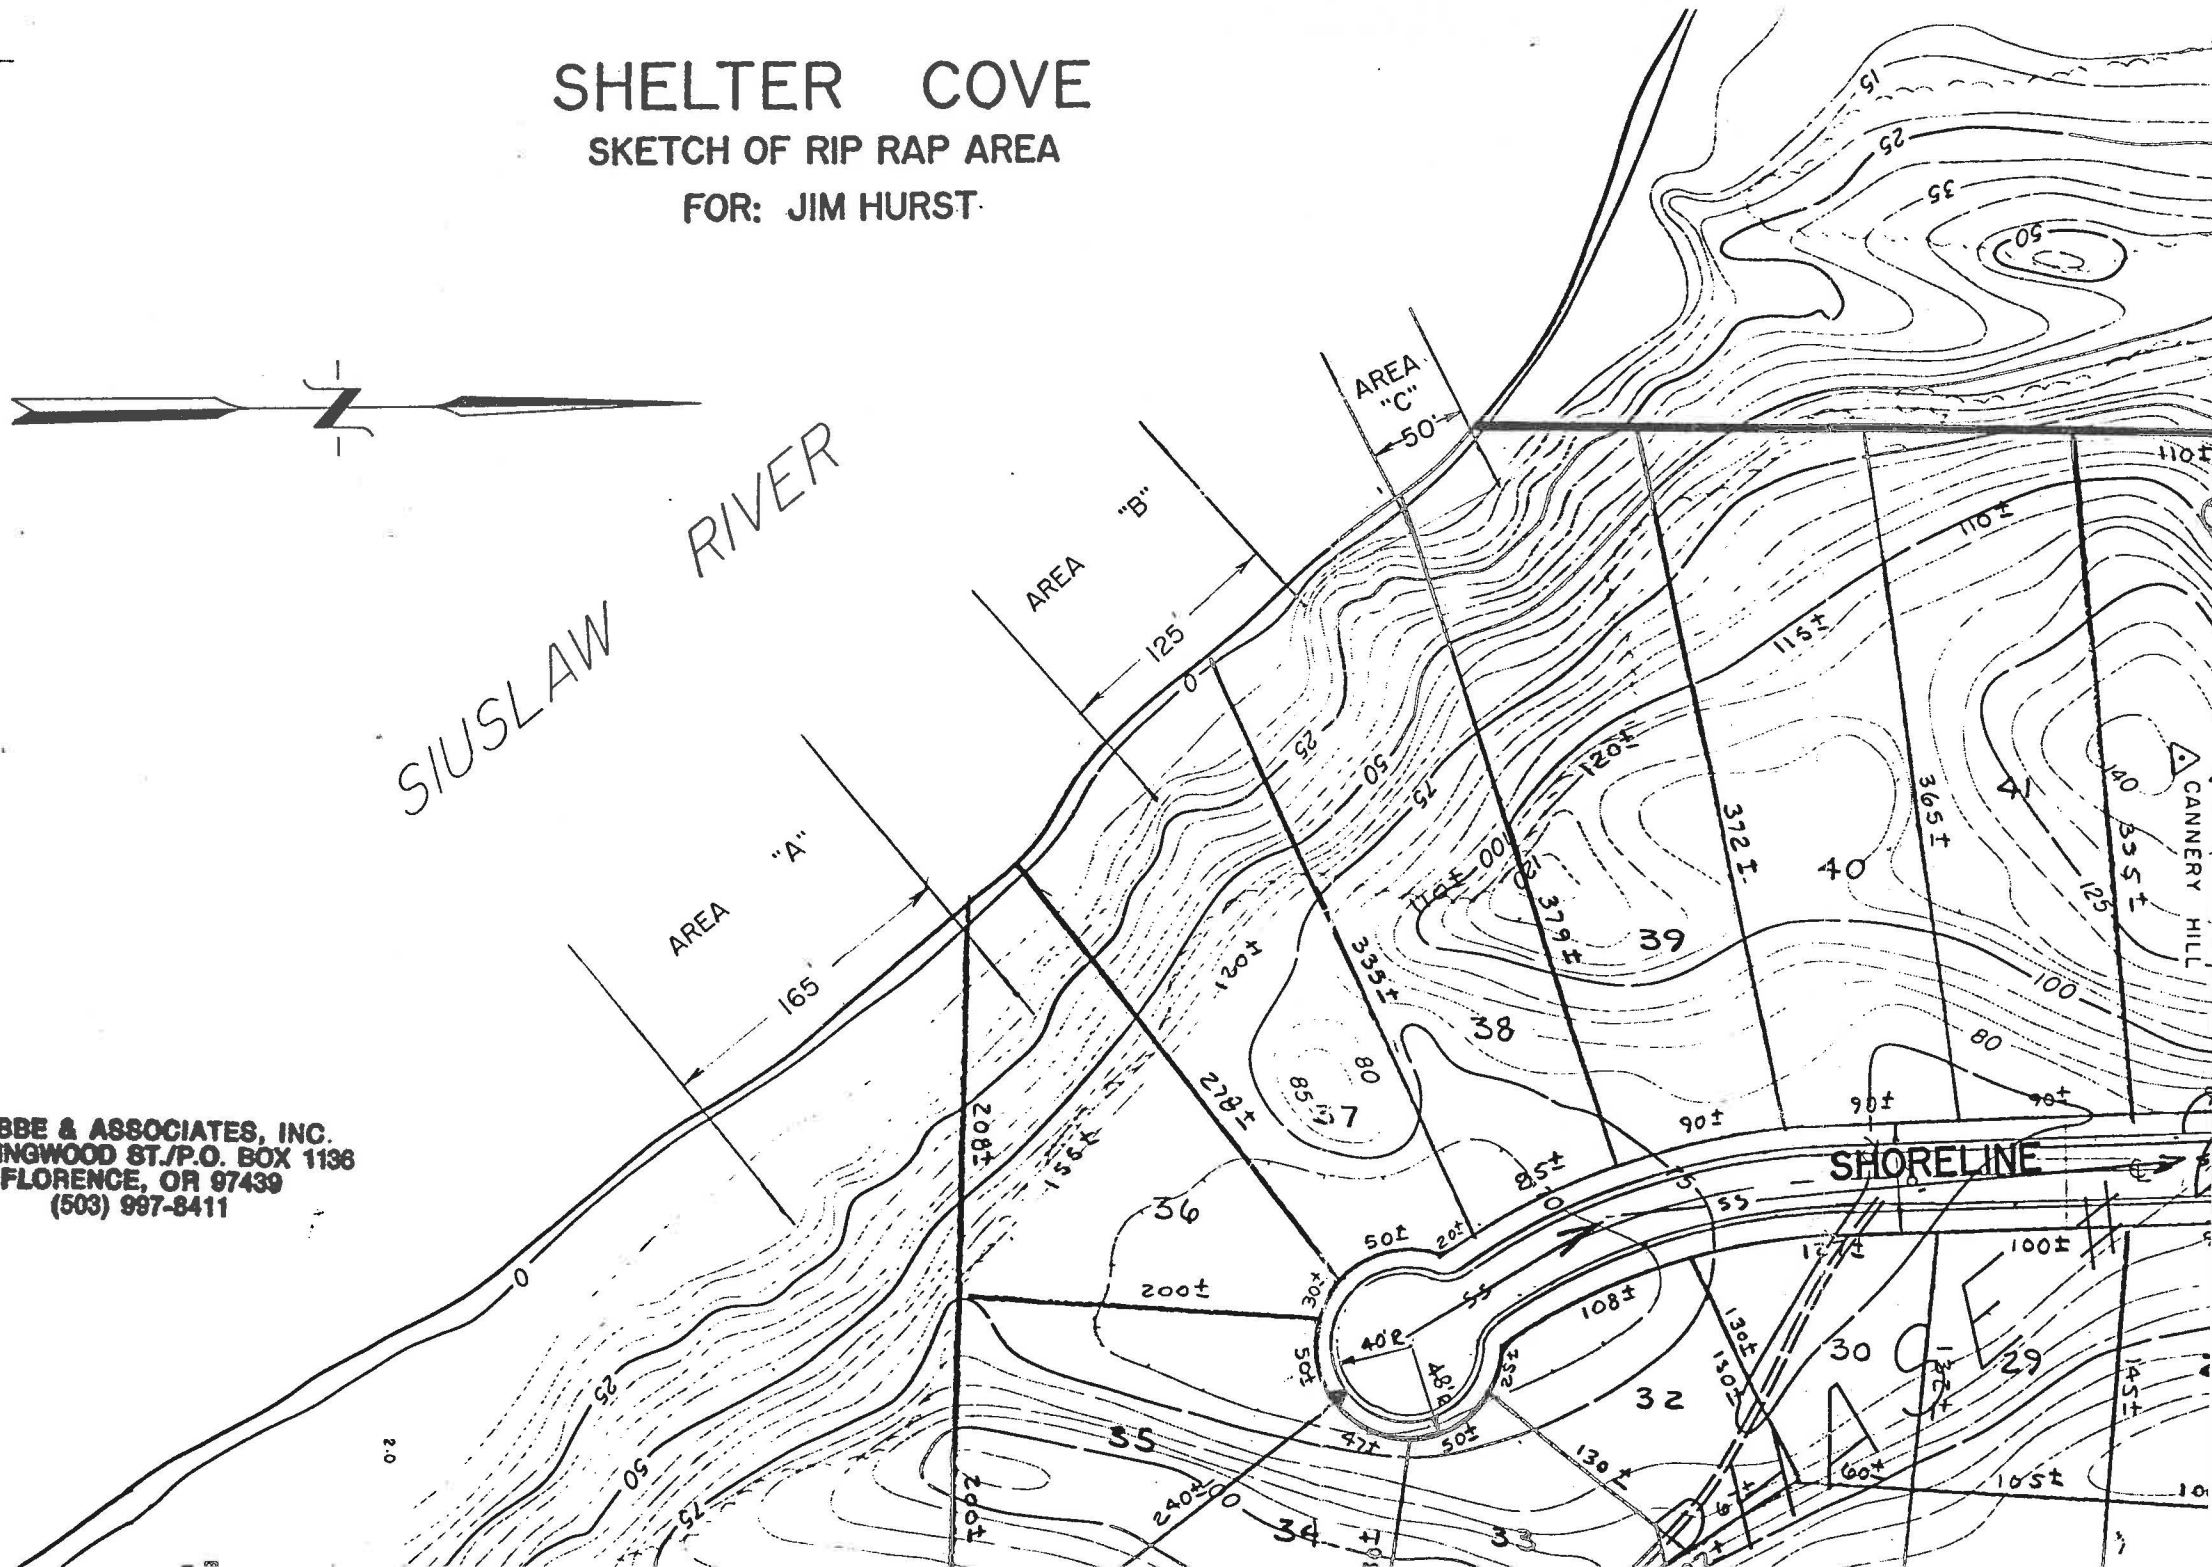
SKETCH OF RIP RAP AREA

Exact locations of two erosion areas are shown on two maps enclosed. The most serious erosion is identified as Area "B" on the map Exhibit I. This is best described as an erosion cove between two existing sandstone points. The erosion is caused by river waves from the SW wind storms and boat traffic wakes. Increased erosion are in some part due to COE installation of pile dike structures and rock groins on the west side of the river. This attempt to stabilize the authorized navigation channel works well.

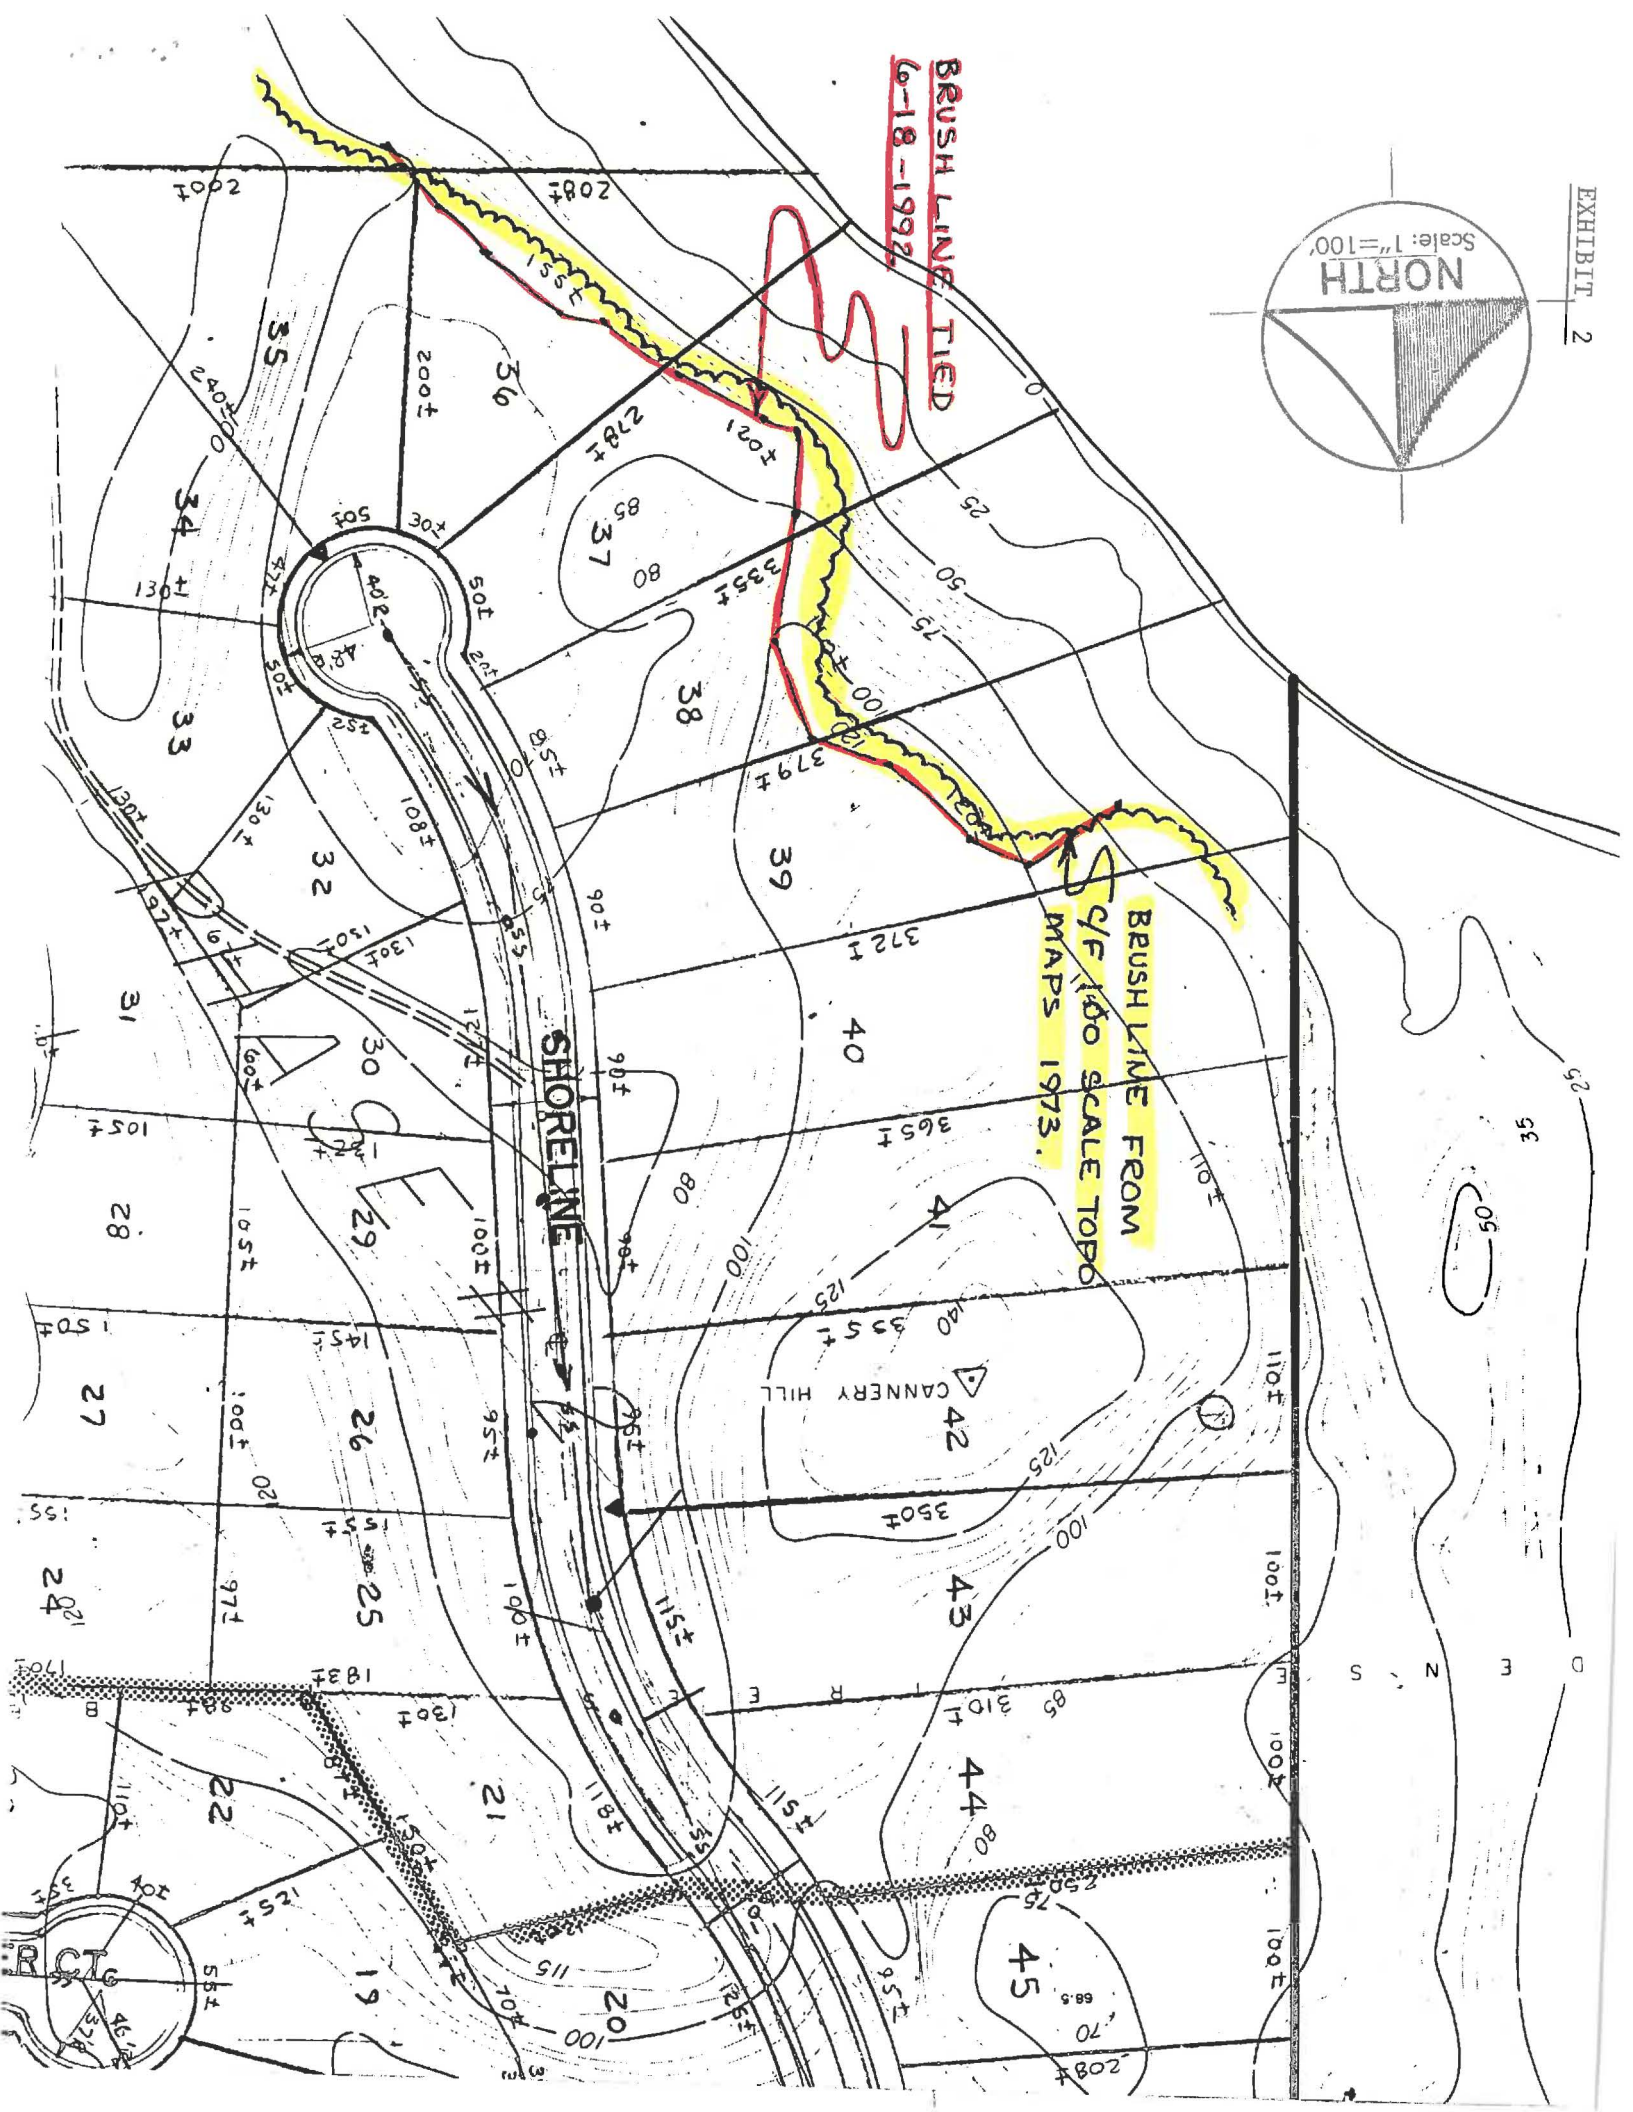
The City of Florence then asked for a top of the bluff erosion rate figure using historic data. This information would then be used to establish safe setback lines on Lots 37 and 38. Mr. Wobbe then submitted a letter and map (Exhibit 2), showing this rate of erosion at the top of the sand bluff. As shown on the maps both lots are deep and there appears to be safe locations on both lots on the east one-third of each property. Exact location of setback lines will be set by the City of Florence. In addition Exhibit I also identifies another erosion Area "C" at the west edge of Lot 39. It is my opinion this erosion area is small and poses no major slope failure problems to Lot 39 at the time. Vegetative cover on this slope will be strengthened by planting and fertilization.

I have estimated the amount of erosion along the top of the bank along the Siuslaw River adjacent to Shelter Cove Subdivision Phase II in the vicinity of Lots 36 - 39 as shown on the enclosed map. Based on a City of Florence topographic map dated 1975 and survey ties to the top of the bank in 1992, I estimate 5 to 25 feet of erosion from the top of the bank in this area between 1975 and 1992. The erosion in this area appears to average less than 1 foot per year.

BRUSH LINE TIED
6-18-1992

BRUSH LINE FROM
Q/F 100 SCALE TOPO
MAPS 1973.
