City of Florence Site Investigation Report – Phase 2 Requirements

CITY OF FLORENCE SITE INVESTIGATION REPORT PHASE 2

Lot 37 Shelter Cove

RE: RECOMMENDED SETBACK & SLOPE RETREAT MITIGATION MEASURES LOT 37 SHELTER COVE FLORENCE, OREGON BRANCH ENGINEERING INC. PROJECT NO. 21-335

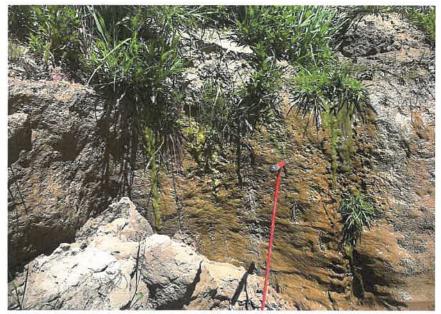
To assess the soil type and groundwater during the May 31, 2022 site investigation BEI staff accessed the bay frontage of the property. The MTD deposits along the adjacent lot to the north were exposed and consisted of dense partially cemented, poorly graded sand with silt and clay. The MTD deposits above the waterline stood vertical for approximately 3- to 7-feet in height, the MTD deposits extended below the waterline to an unknown depth. An area of deposition along the piers near Cannery Point was noted from drone photos. In this area it appears the MTD deposits extend further out into the bay. Hand probing areas close to shore had 1- to 2-feet of loose sand overlying the MTD shelf that projected out into the bay. Groundwater was noted issuing from the boundary between the MTD deposits and the overlying sand. The rate varied, but was estimated to be at least a gallon per minute in areas where erosion had concentrated the flow. Piping of the overlying sand deposits was noted where the groundwater flow volume was highest. Deposits of the sand were also noted in the water below these areas.

Photo 1: MTD deposits and groundwater issuing from the boundary with overlying sand.

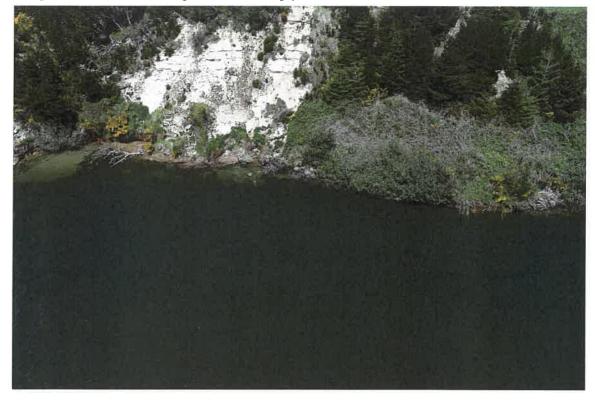
Based on historical imagery obtained from EDR Lightbox (attached) for the following years 1954, 1976, 1982, 1988, 1994, 2000, 2005, 2009, 2012, 2016, and Google Earth Imagery for the years 2005, 2012, 2016, and 2019, the site has experienced periods of bay shore erosion; however, the most significant alternation to the site is associated with mass grading of the area during the development of the Shelter Cove subdivision. The resolution of the aerial images also makes determining a rate of erosion for the site difficult as the precision of any measurements would be on the order of tens of feet. The 1954 aerial photo shows the site vicinity as partially vegetated dunes descending as sand clear of vegetation to the river bank. By 1976 a series of four groins (constructed in 1974) on the south bank of Siuslaw Bay. One of the groins is directly across the bay from the site. Also visible in the 1976 aerial photo is an area of sand clear of vegetation in the site vicinity. This area was vegetated in the 1954 aerial photo. The site vicinity remains relativity unchanged until the 1994 aerial image that shows construction of the Shelter Cove subdivision altering the site and vicinity by removing vegetation and performing mass grading operations. Mass grading of the site appears to consist of a flattening of the dune for a building pad and clearing of the slope to the bay. In the 1994 aerial photo the slopes descending to Siuslaw Bay are mostly clear of vegetation and remain relatively clear until the 2009 to 2012 aerial photos that show sparse vegetation in 2009, and relatively dense vegetation in 2012. Sometime between 2012 and the next available aerial image in 2016, a shallow landslide begins to develop on the adjacent lot's bayside slopes to the north. At the time of BEI site visits in 2021 and 2022 the landslide appeared to be entirely within the adjacent lot to the north; however, we were not able to locate property corners so this could not be confirmed. The exact cause of the landslide is unknown, but based on the lack of rip-rap armoring, we suspect that a combination of piping of the sand overlying the MTD deposits, and erosion of the MTD deposits lead to recession at the toe of the slope to the point where the overlying sand experienced a loss of lateral support and translational landslide resulted. Because of the dense vegetation along the slope and bay frontage of Lot 37, the site investigation was limited to the periphery and aerial reconnaissance using a drone. The bay frontage of the site appears to be composed of rip-rap that extends up into the vegetation a distance of 3- to 4-feet where it was visible. Below the vegetation line, which roughly corresponds to the high-water line, the rip-rap extends for a short distance before the shore drops off near vertical, to vertical with depths greater than 6-feet (estimated with a stick at the northwest corner). Drone photographs show the conditions observed in the northwest corner to be consistent along the length of the property. Shadows along the submerged bank indicate possible areas of concavity that may be undercut submerged banks in the MTD deposits.

Photo 2: Lot 36 (presumed left of vegetation line) and part of Lot 37 are visible in this photo. Note the exposed sand from the landslide on Lot 36, loose sand deposited below the waterline on left half of photo, and the dense vegetation and deeply incised banks below the waterline on Lot 37.

At the time of our site observations site slopes and the shoreline appear to be stable; however, if left unchecked the erosion of submerged bank material is expected to continue. To determine a site-specific rate of erosion and possible mitigation methods, the shoreline of the site would need to be accurately surveyed. If possible, an investigation utilizing either sonar, or if conditions permit, a water-based reconnaissance of the conditions below the waterline would need to be conducted. A survey of the site would also determine if the landslide on the adjacent lot was contained within that lot.

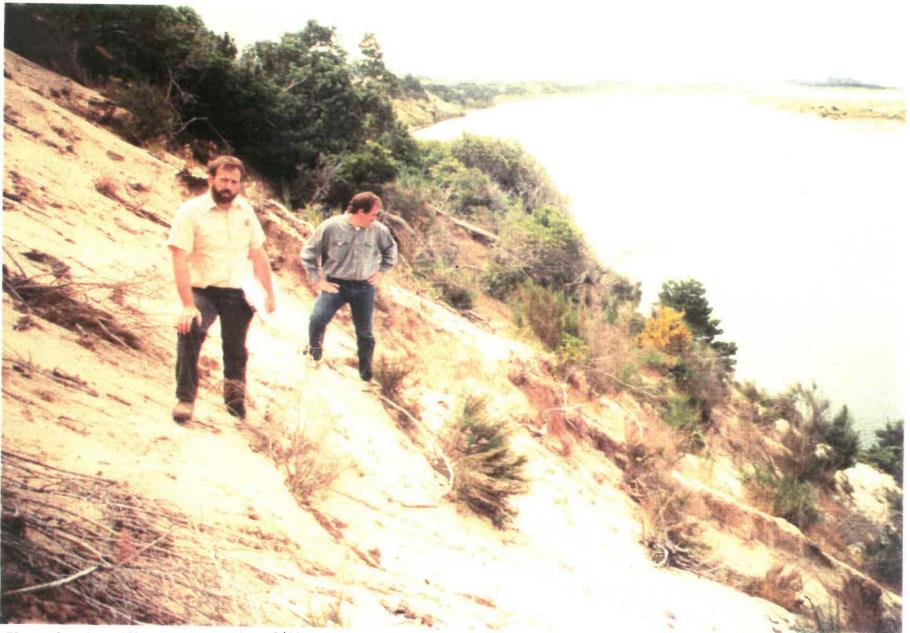
Photo 1 - by Wilbur E. Ternyik - 6/92 Location - Jim Hurst's Shelter Cove Subdivision, Siuslaw River, Florence, Oregon. Gene Wobbe and Don Hazen standing in middle of upper portion of slide area, on Lots 37 and 38.

Note - Progressive nature of slope failure and shrubs sliding down the slope, into the river. Restoration of riparian vegetation is impossible until river toe of slope is stablized.
