EXHIBIT G

June 18, 2021

**RE: GEOTECHNICAL SITE EVALUATION
LOT 37 SHELTER COVE
FLORENCE, OREGON
BRANCH ENGINEERING INC. PROJECT NO. 21-335**

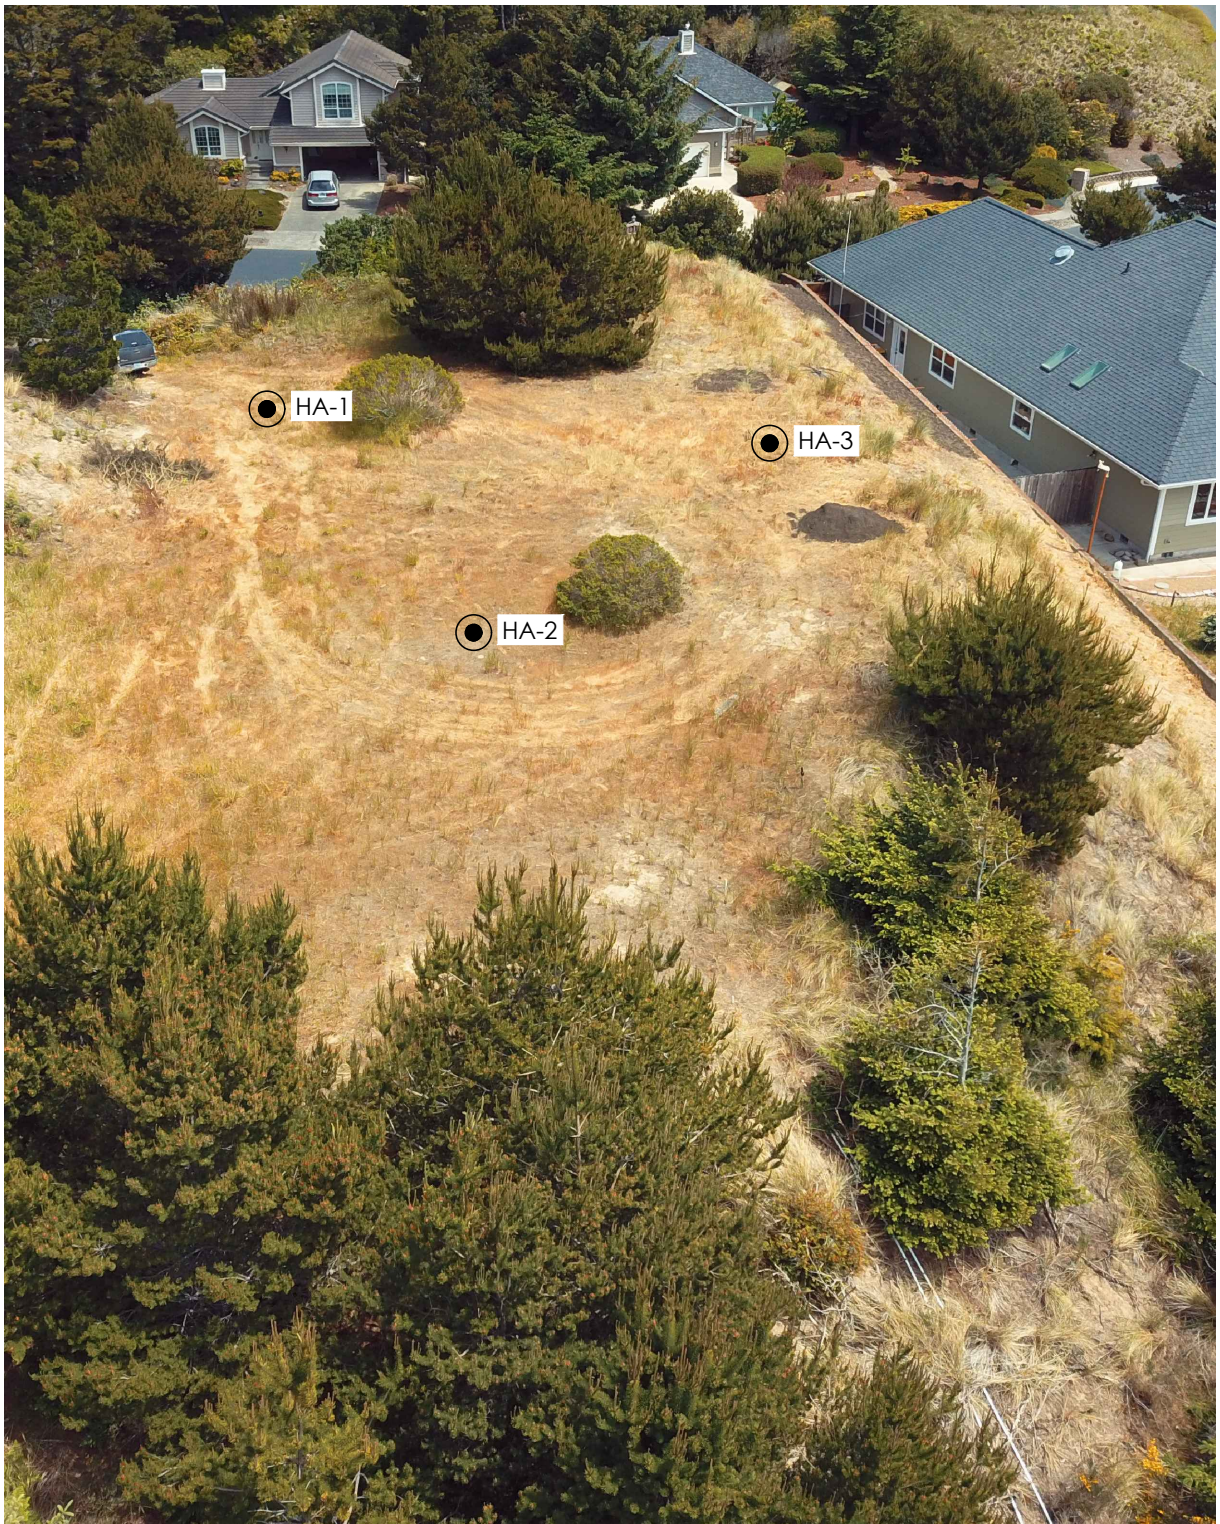
FIGURE-1

● HA-1 INDICATES APPROXIMATE LOCATION OF EXPLORATORY BORING

SITE AERIAL PHOTO - LOT 37 SHELTER COVE

Three exploratory hand-auger borings were advanced to approximately 4.5-feet below ground surface (BGS) see Figure-2 for hand auger locations. Site soils generally consist of tan-brown, poorly graded, fine-grained sand. Moisture contents of the sand were generally observed to be damp after penetrating below the dry crust of the surficial sand. Even though no moist or wet
