CITY OF FLORENCE
SITE INVESTIGATION REPORT PHASE 2

Build SFD on lot 37 skeltrcur
Proposal

56 Shoreline dr Florence
Street Address

**RE: EROSION/RECESSION SITE ASSESSMENT
LOT 37 SHELTER COVE
FLORENCE, OREGON
BRANCH ENGINEERING INC. PROJECT NO. 21-335**

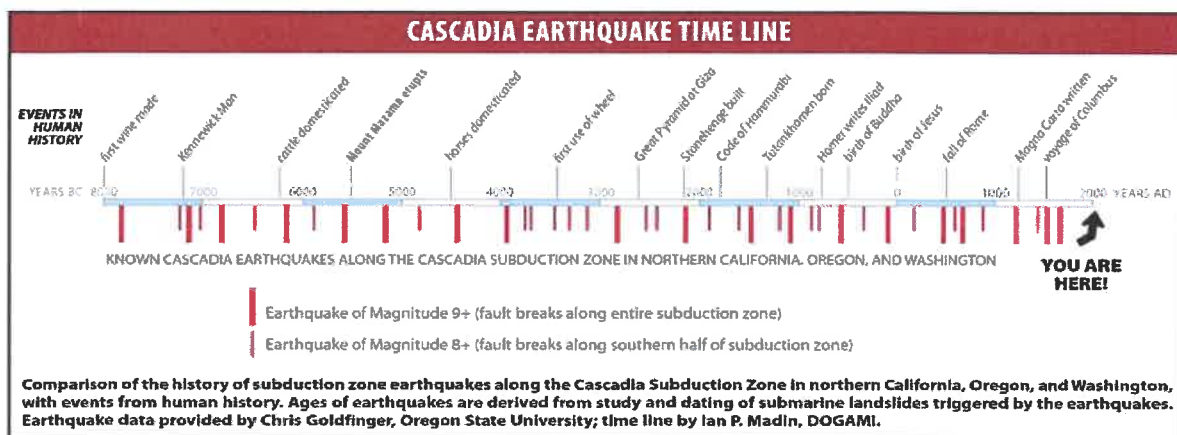
The site is located approximately 60-miles east of the Cascadia Subduction Zone, which is a zone of converging tectonic plates that historically produces major earthquake events that is located to the west of the Oregon Coast. The figure below shows a timeline of historical Subduction Zone earthquake events. The nearest mapped active fault is approximately 7.3-miles to the southwest of the site and is labeled as a part of the Cascadia fold and fault belt.

The HazVu website shows that the subject site is expected to experience severe shaking in the event of a Cascadia Subduction Zone earthquake and very strong shaking for lesser earthquakes. HazVu has also characterized the site as having a high-risk landslide and for earthquake induced liquefaction of the subsurface soils.

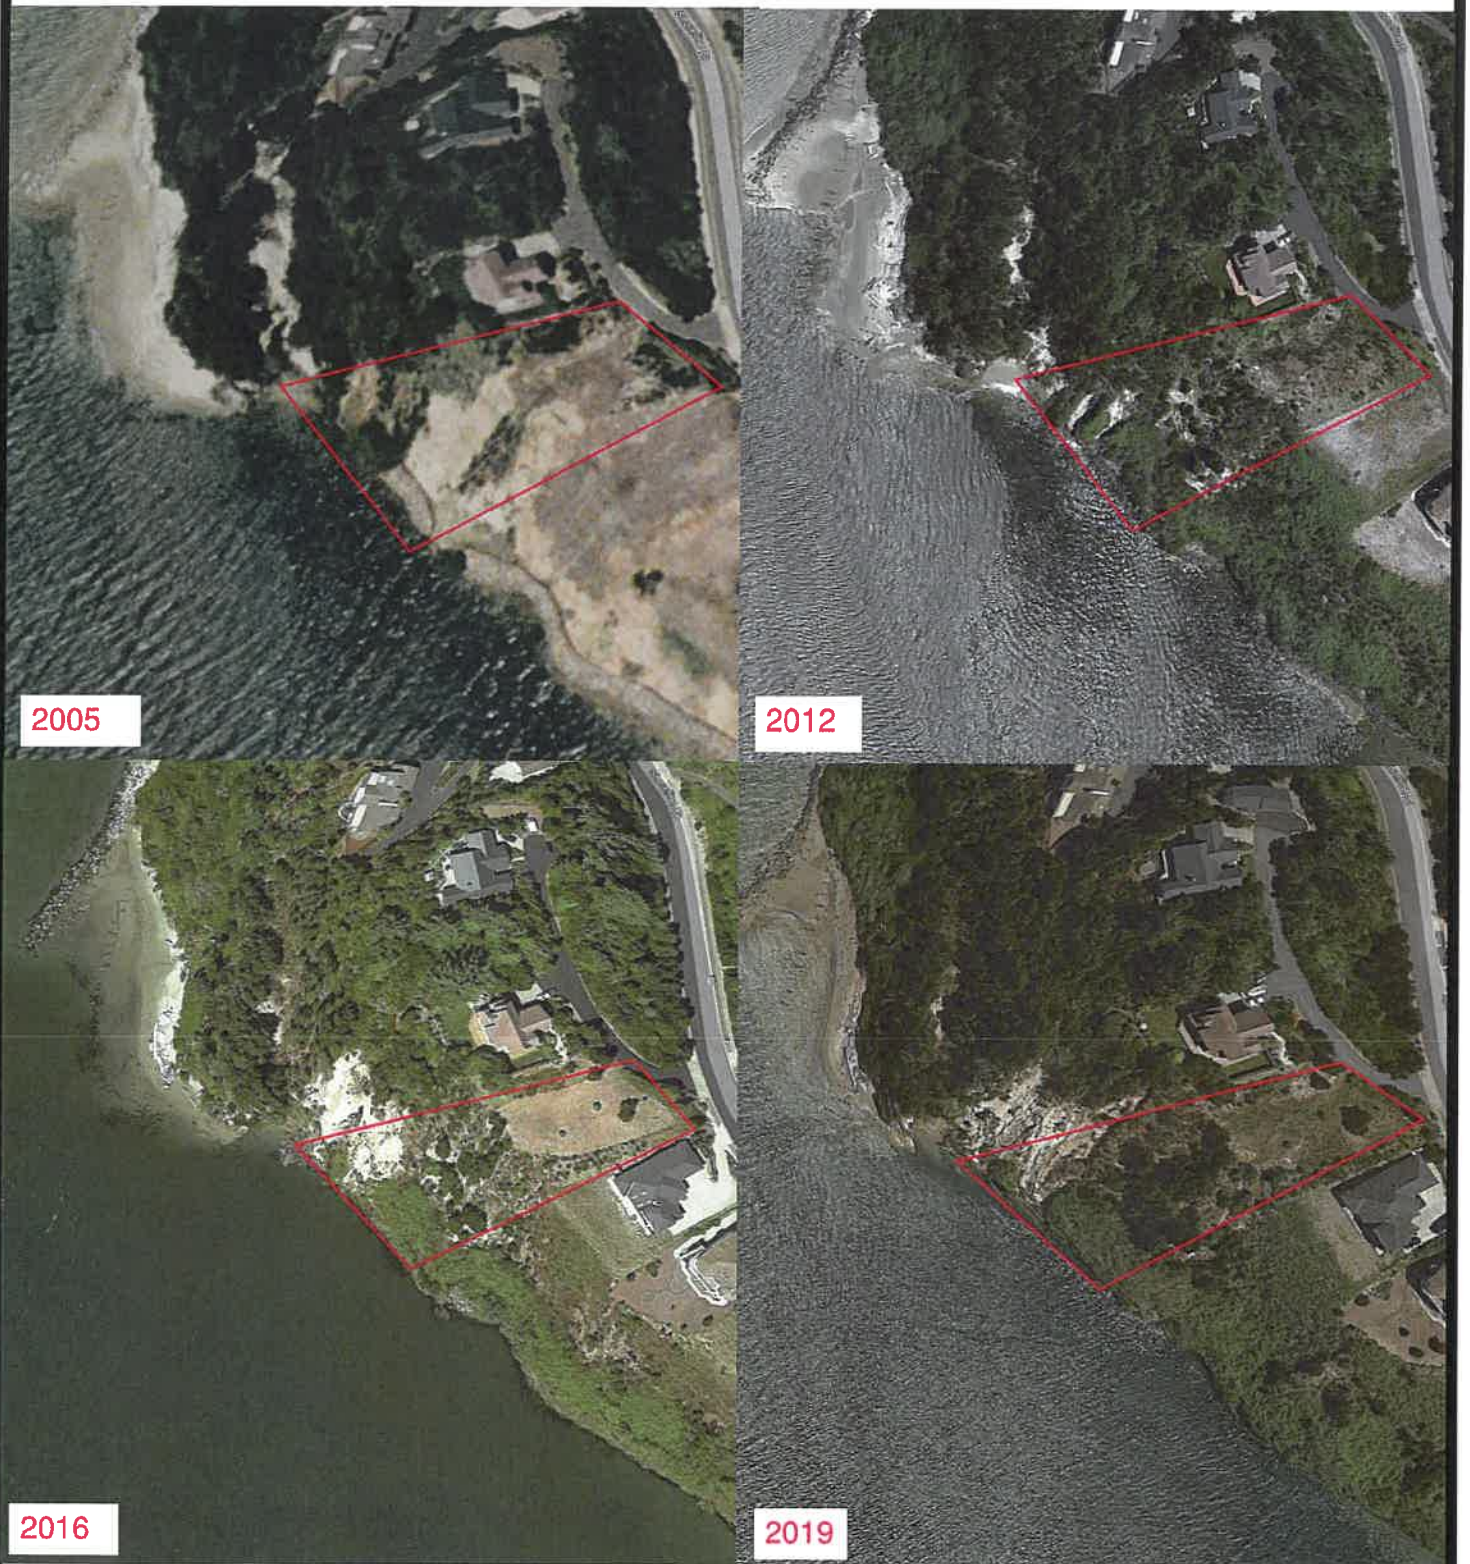
SITE GEOMORPHOLOGICAL AND GEOLOGIC FEATURES
LOT 37 SHELTER COVE TAX MAP 18-12-16-41 LOT 700

Estimated Lot Boundary.
No Property Corners
Were Found During The
Site Investigation
