City of Florence Site Investigation Report – Phase 2 Requirements

CITY OF FLORENCE SITE INVESTIGATION REPORT PHASE 2

Lot 37 Shelter Cove

RE: RECOMMENDED SETBACK & SLOPE RETREAT MITIGATION MEASURES LOT 37 SHELTER COVE FLORENCE, OREGON BRANCH ENGINEERING INC. PROJECT NO. 21-335

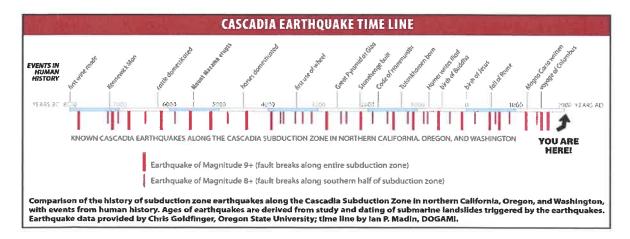
The site is located approximately 60-miles east of the Cascadia Subduction Zone, which is a zone of converging tectonic plates that historically produces major earthquake events that is located to the west of the Oregon Coast. The figure below shows a timeline of historical Subduction Zone earthquake events. The nearest mapped active fault is approximately 7.3-miles to the southwest of the site and is labeled as a part of the Cascadia fold and fault belt.

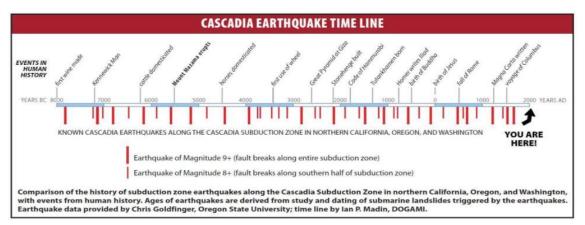
The site is located near the Cascadia Subduction Zone, which is a zone of converging tectonic plates that historically produces major earthquake events that is located to the west of the Oregon Coast. Figure 1 below shows a timeline of historical Subduction Zone earthquake events. The nearest mapped active fault is approximately 7.3-miles to the southwest of the site and is labeled as a part of the Cascadia fold and fault belt.
