Boire Associates Inc.*Geotechnical Engineering Solutions*520 NW 4th Street
Corvallis, Oregon 97330
Tel: 541.753.5344
Fax: 541.753.5347**Addendum #2 (Technical Memorandum)**

To: Jim Hurst	From: Todd Boire, P.E.
Fax: 541.902.7999	Pages: 1
Phone: 541.997.5157	Date: July 13, 2004
Re: Shelter Cove	Cc:

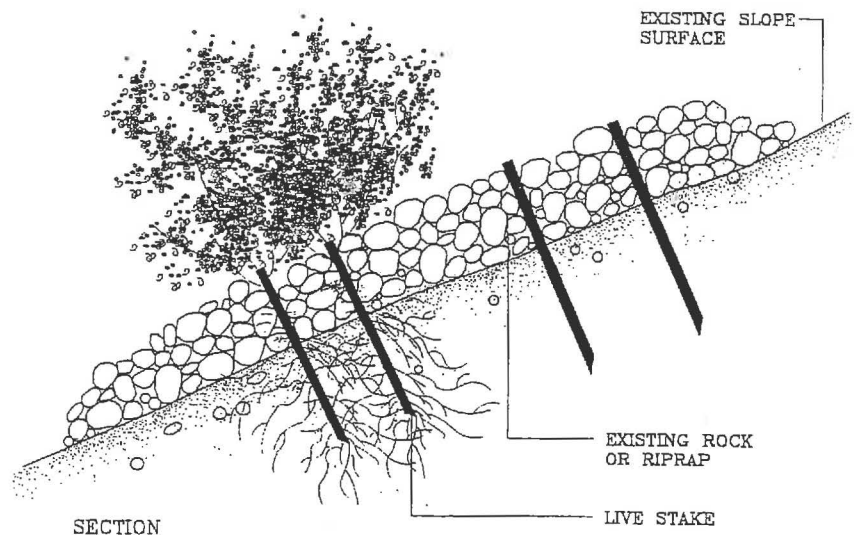
Figure 8-1. Schematic illustration of an established, growing vegetated riprap revetment.

Joint planting refers to the insertion of live cuttings (stakes) in the openings or joints between the rock in a riprap revetment, as shown in Figures 8-1 and 8-2. Alternatively, the cuttings can be tamped into the ground at the same time the rock is being placed on the slope face. The latter approach facilitates installation of the cuttings but also complicates rock placement and increases the likelihood of damage to the cuttings if the rock is tailgated or dumped in place.

Live cuttings placed in this manner should extend into the soil beneath the stone armor, as illustrated in Figure 8-1. The objective is to have these live cuttings root in the soil beneath the riprap, thus reinforcing the bank, anchoring the riprap, and improving drainage by extracting soil moisture.
