Stormwater Management Report

Our Coastal Village Florence

October 2024 | KPFF Project #2400153

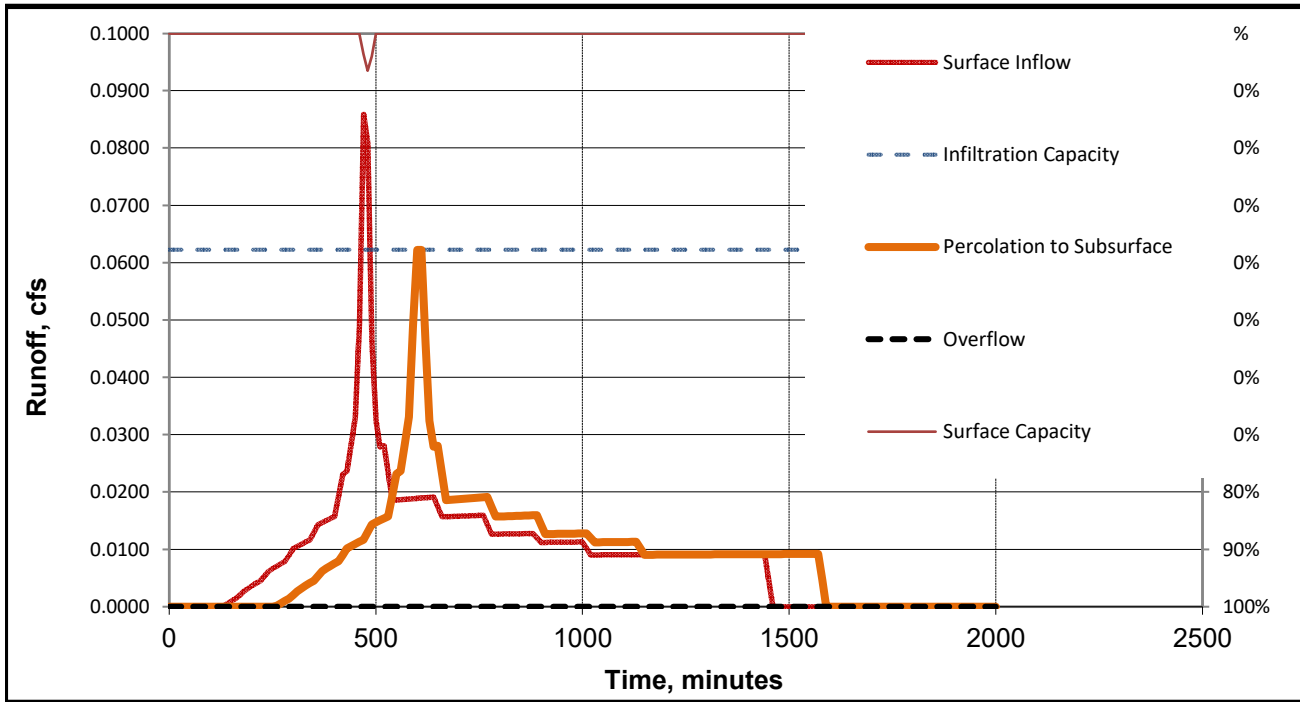
Water Quality Event Surface Facility Modeling

Surface Storage Capacity	390	cf
Infiltration Area	1,076	sf
GM Infiltration Rate	2.5	in/hr
Infiltration Capacity (avg)	0.062	cfs

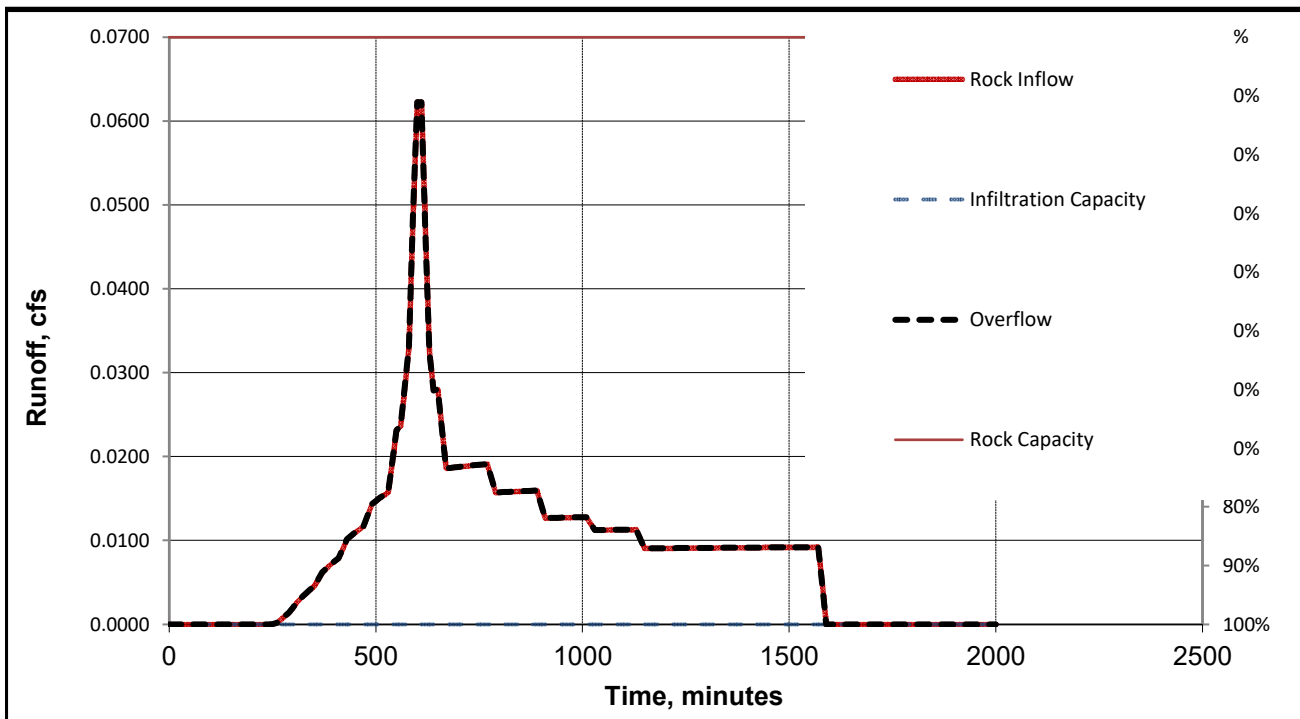
Water Quality Event Below Grade Modeling

Recurrence Interval	Peak Flow (cfs)	Volume (cf)	Rock Capacity	Meets Infiltration?
WQ	0.0623	1,062	N/A	See Detention
2-Yr	0.4500	5,927	N/A	10-Yr Infiltration Volume (cf): 387
5-Yr	0.4732	6,262	N/A	
10-Yr	0.6230	8,248	N/A	
25-Yr	0.7251	9,613	N/A	
50-Yr	0.8042	10,675	N/A	
100-Yr	0.8861	11,790	N/A

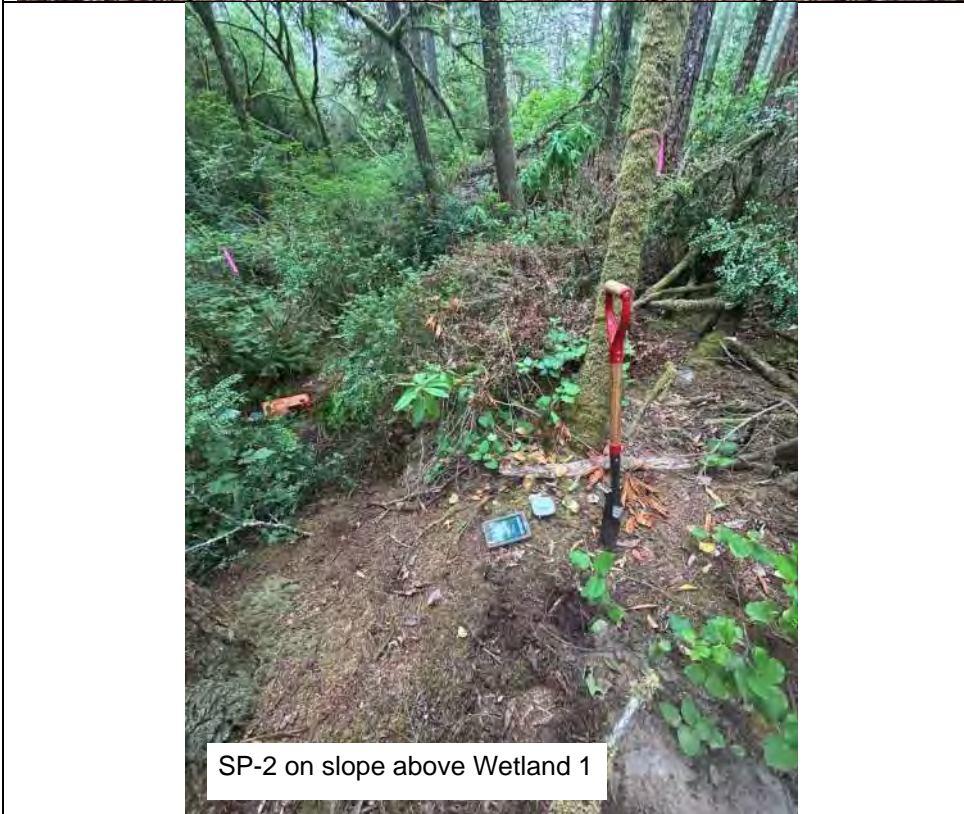
Date: 8.22.24
